Arkema Facility - Harvey Response

Arkema Inc.

September 6, 2017

Project #109489 Summary

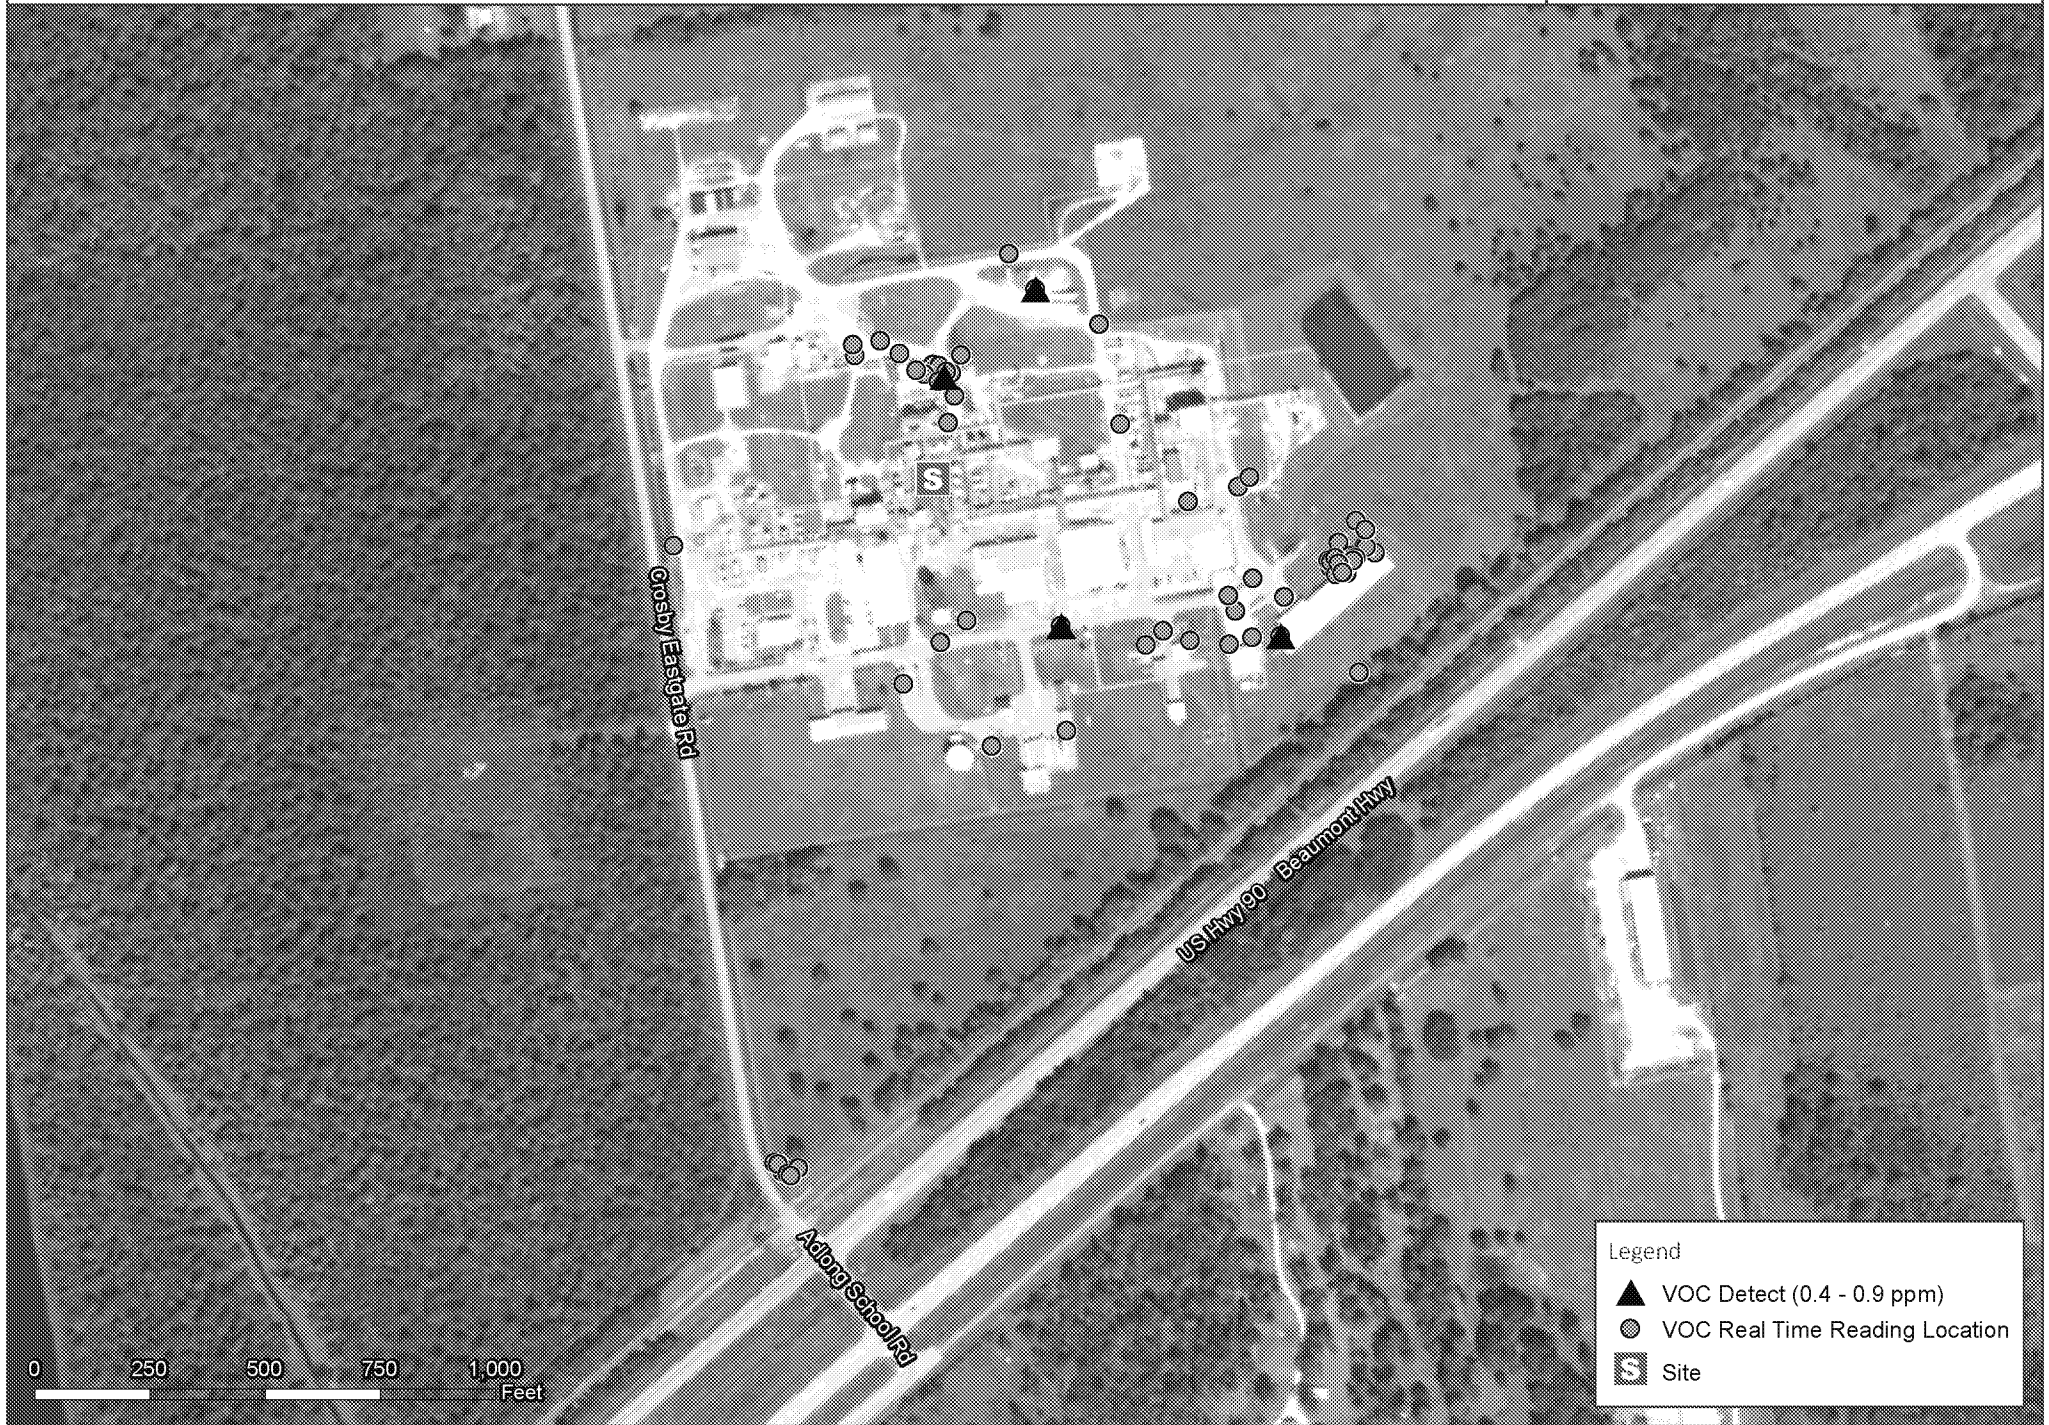
VOC Hand-held Real-time Reading Locations - Worker Activity

Harvey Response - 06:00 September 5, 2017 to 06:00 September 6, 2017

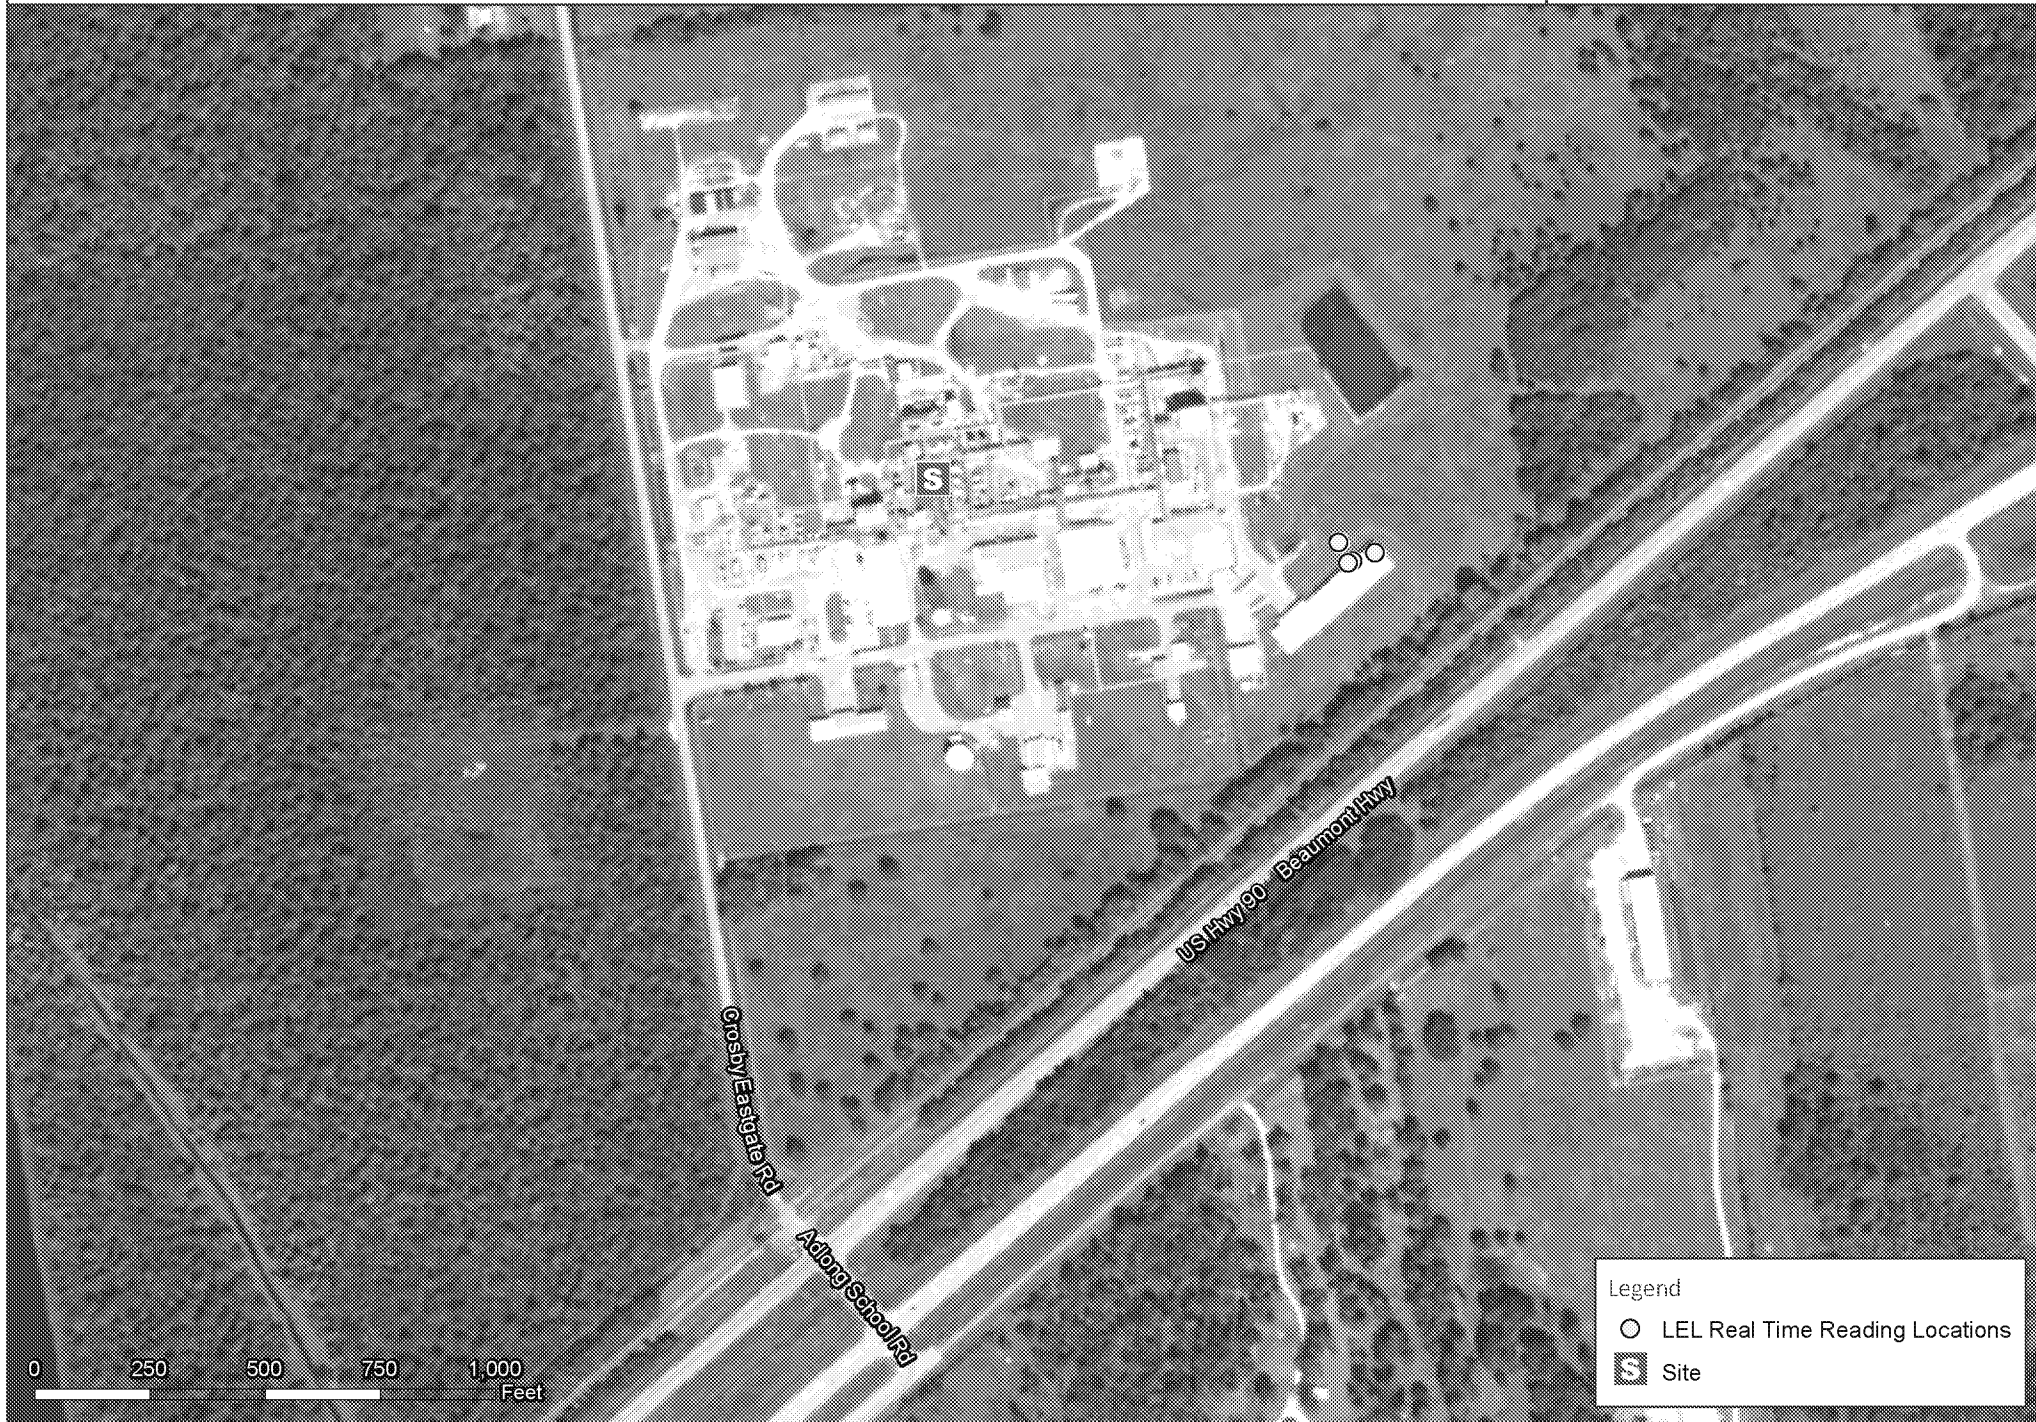
LEL Hand-held Real-time Reading Locations - Worker Activity

Harvey Response - 06:00 September 5, 2017 to 06:00 September 6, 2017

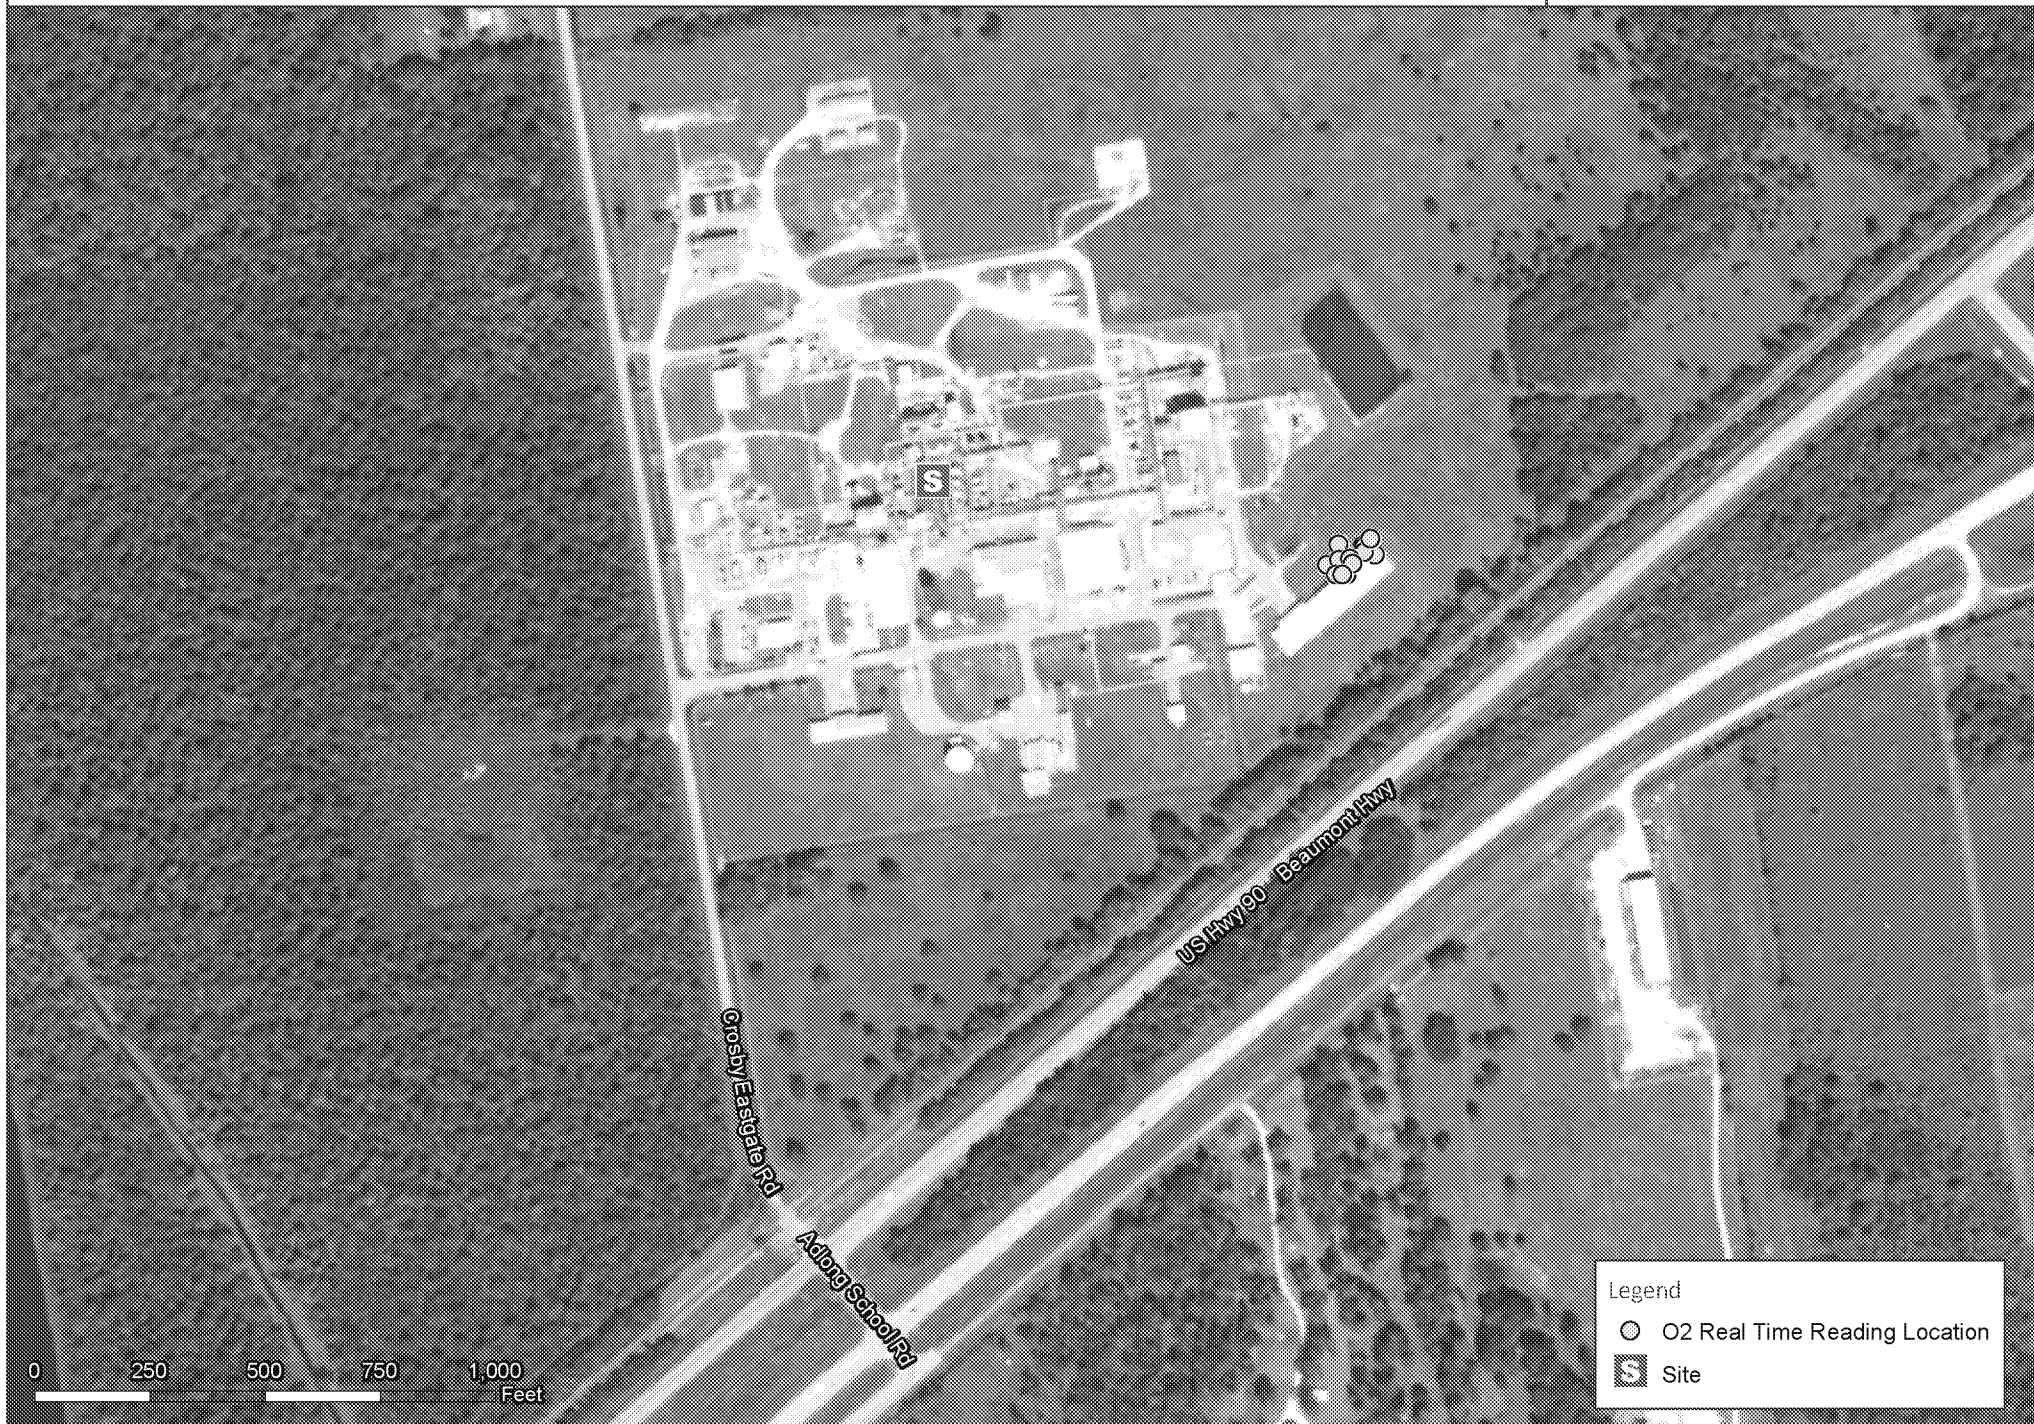
Oxygen Hand-held Real-time Reading Locations - Worker Activity

Harvey Response - 06:00 September 5, 2017 to 06:00 September 6, 2017

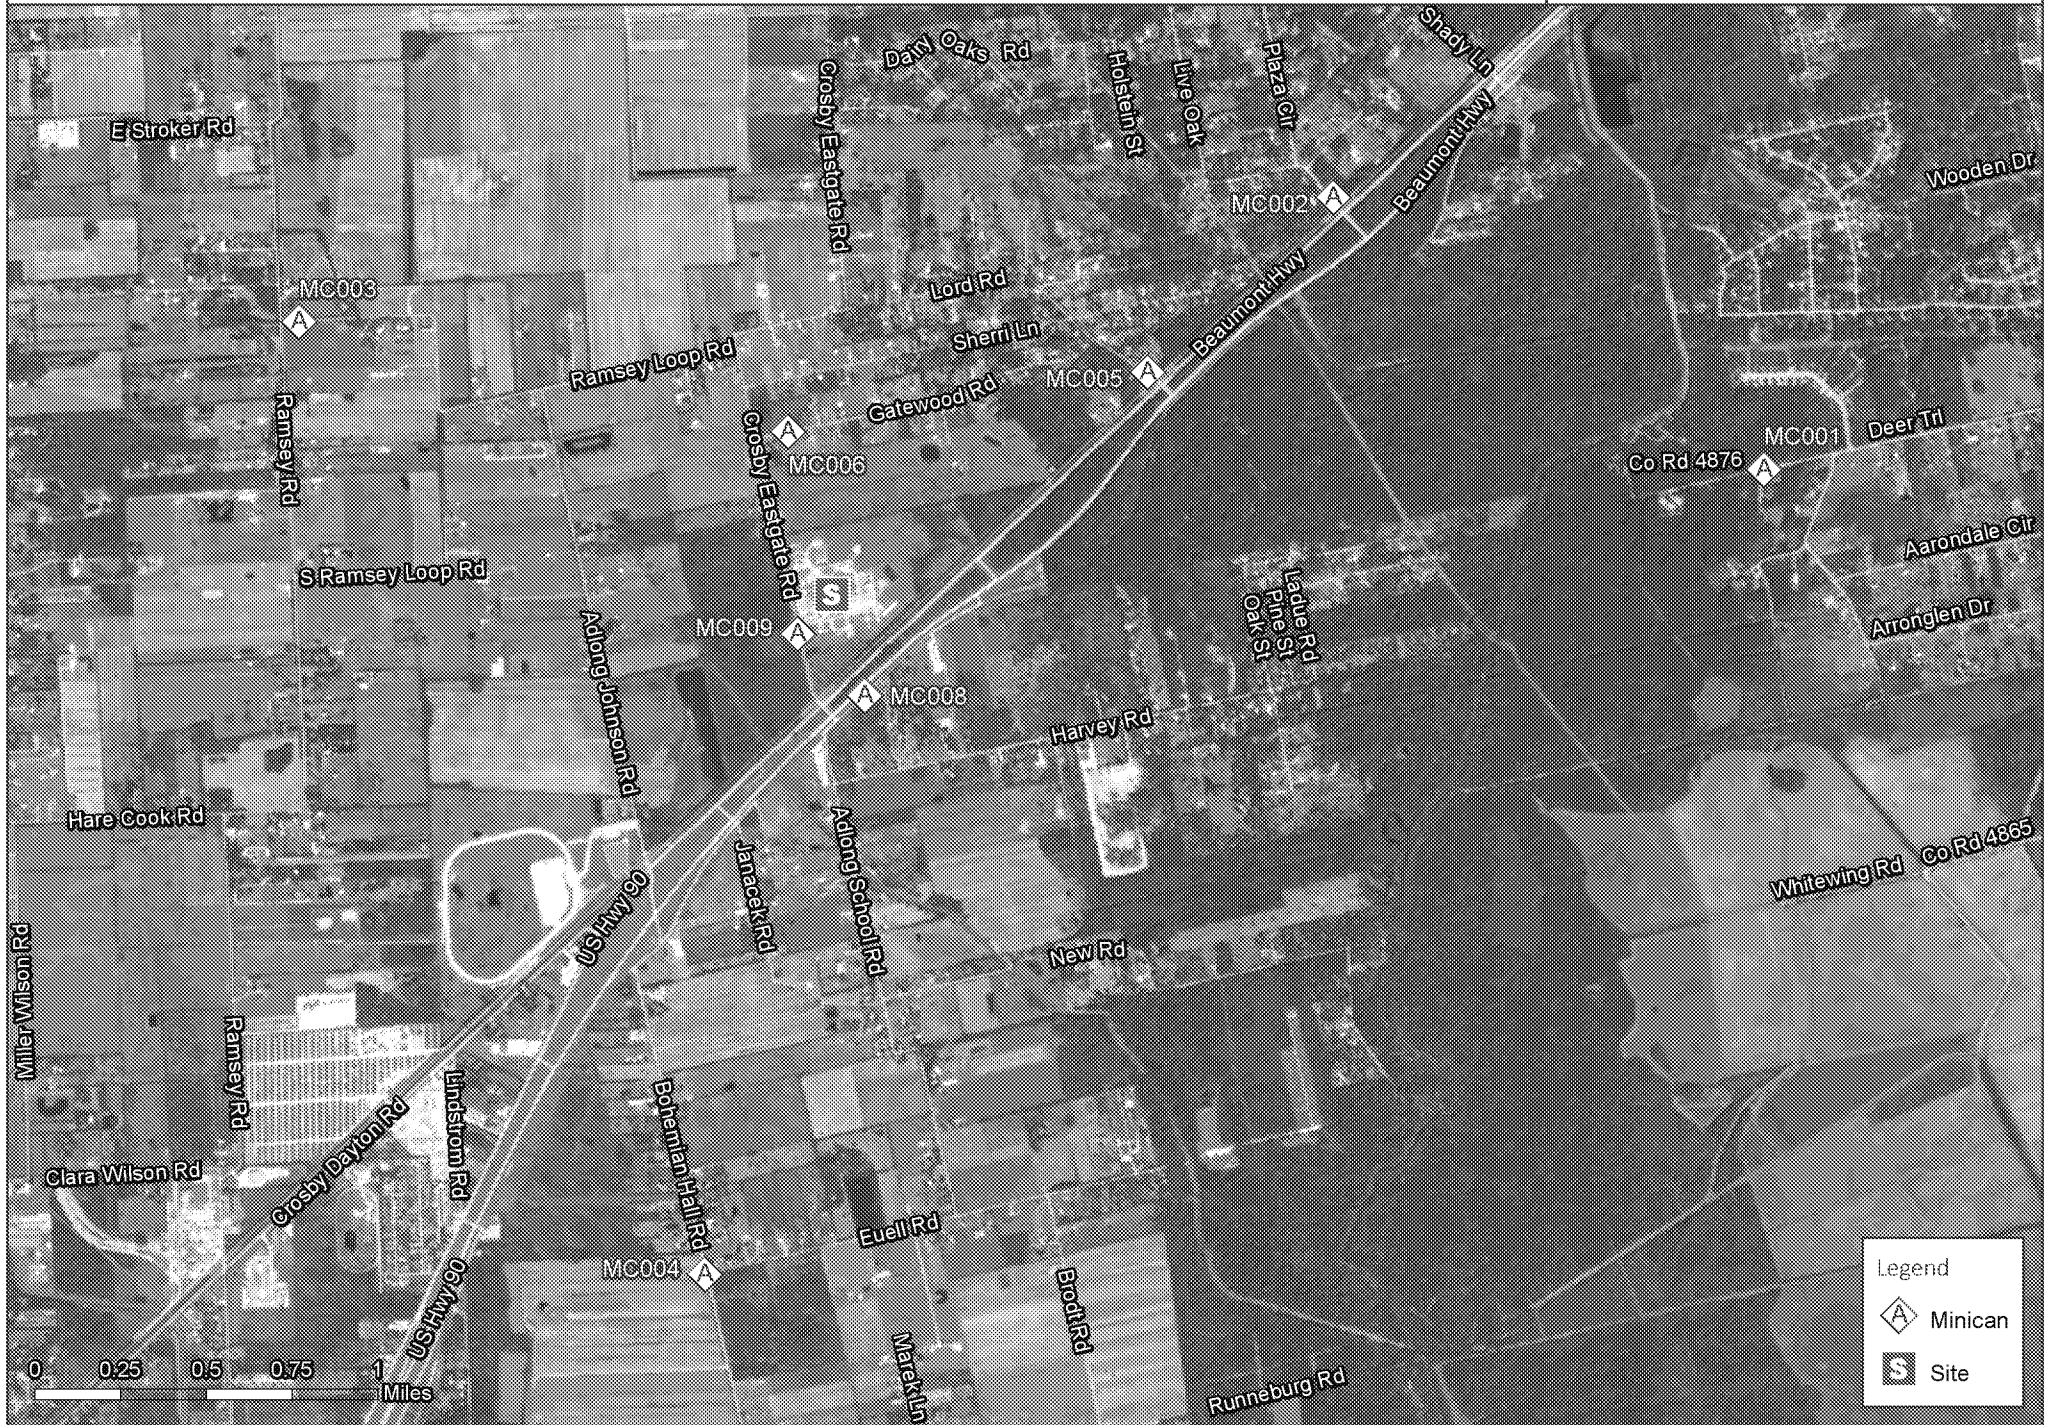
Analytical Air Monitoring Station Locations as of September 6, 2017

Map of Analytical Air Sampling Locations

To supplement real-time air monitoring, CTEH® deployed areas along the perimeter of the evacuated area within the community. Evacuated canister (Minican™) samplers were regulated to collect air evenly over a 24-hr period. Analytical air samples will be submitted to SGS Galson Laboratories, an AIHA-accredited laboratory, for analysis using EPA Method TO-15. A map highlighting the analytical air sampling locations is provided as **Attachment C**. Analytical Air Sampling Results will be reported upon receipt from the laboratory.
